PinePhone 1.2 VCONN Hardware Fix

This page details a hardware fix for an issue that was found on early PinePhone hardware revisions (see <u>PinePhone#Hardware revisions</u> for an overview of the different revisions) and has been fixed since the 1.2a hardware revision.

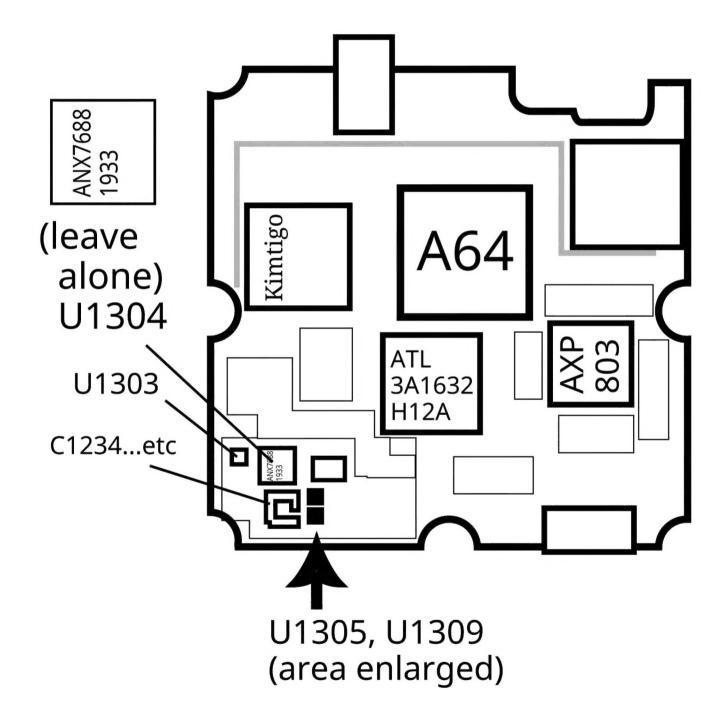
Close-up picture of the two identical switches the issue originates from, with the ANX USB controller in the frame

The issue arises due to the switches that were chosen up to v1.2a (the a revision excluded) of the PCB assembly: the infamous AW3512, labelled U1305 and U1309 on the schematic. Instead of leaving the output pin "dangling" with a high impedance when disabled, the switch pull the output down. This feature is intended for discharging a capacitor, hence its "Quick output discharge" name. This is an excerpt from the datasheet:

This issue prevents cable plug/orientation detection and USB-PD communication. ANX always sees cable as plugged even if none is plugged. There's no SW workaround for automatic detection of cable plug or power role.

Hardware workaround is desoldering U1305 and U1309 switches (BGA like packages). This will void the VCONN control, but it will release the CC pins for their proper connection detection and negotiation roles.

HW fix is to replace AW3512 with a variant of the chip that preserves the EN signal polarity and that doesn't have the "quick discharge function" that ties the output to the GND via a 75 Ohm resistor when the switch is OFF. mozzwald used NCP334FCT2G as a replacement. PCBA revision 1.2a onwards incorporate that fix.

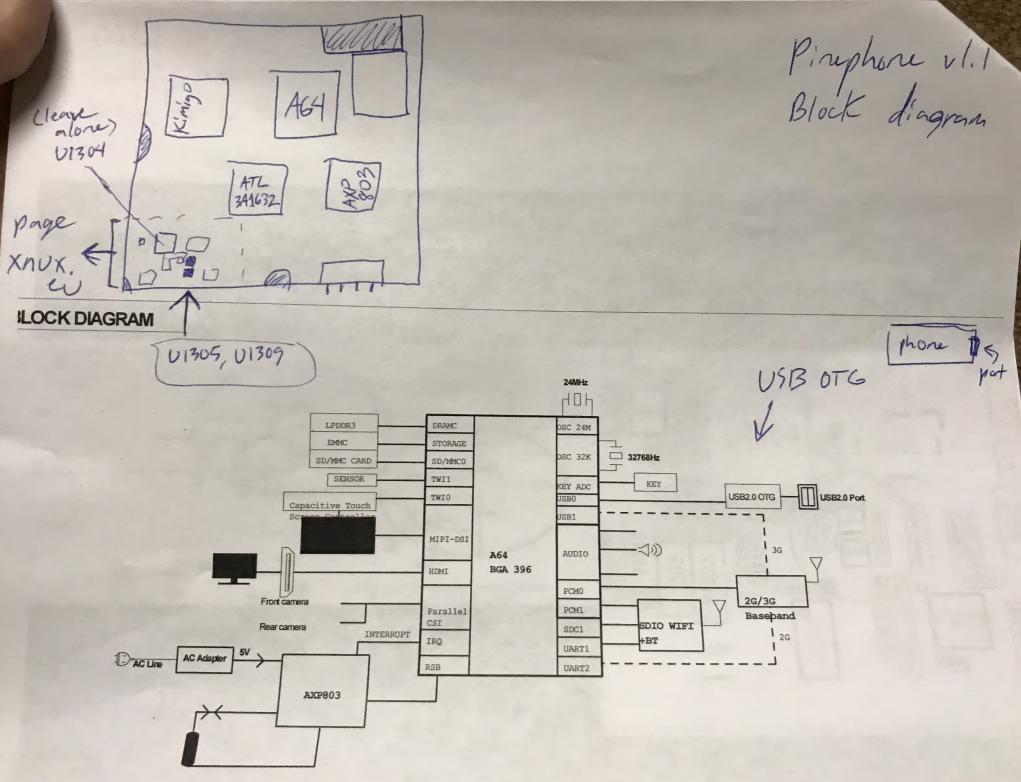
Excerpt from the PinePhone schematic showing the two components.

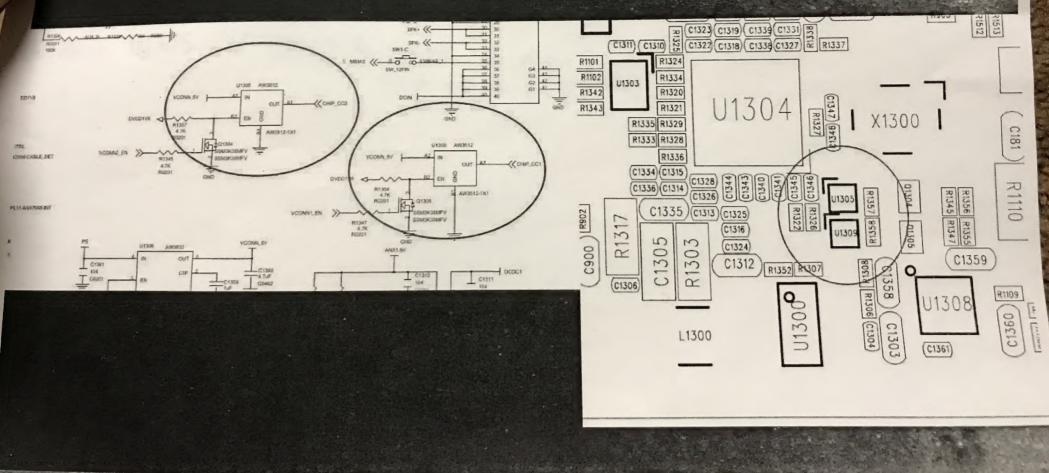
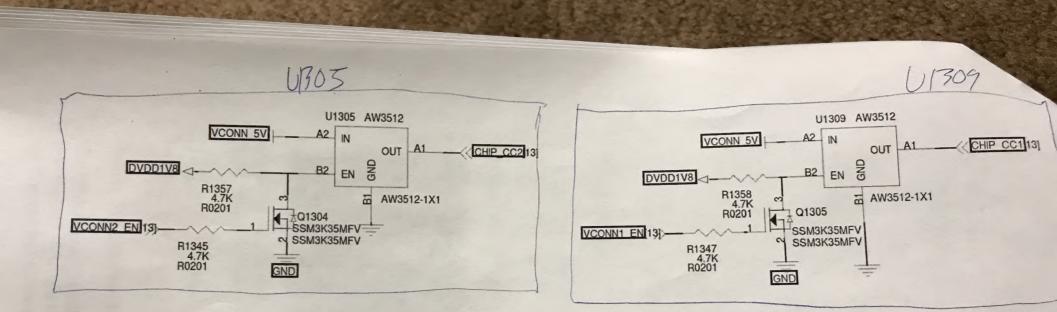
To fix USB-C CC pins, we need to desolder VCONN switches that are tying the CC pins to the ground when they're off, p from functioning correctly.

AW3512 switches Desolder U1305 and U1309 to release CC ping which are always grounded

· careful of other components · carefully remove + heat U1305, U1309 · careful not to short things around/below
